Warrnambool Beach Access Strategy

The recommendations of the Strategy are intended to provide guidance for Warrnambool's 33 beach access points between Shelly Beach and Logans Beach, over a 15-year timeframe.

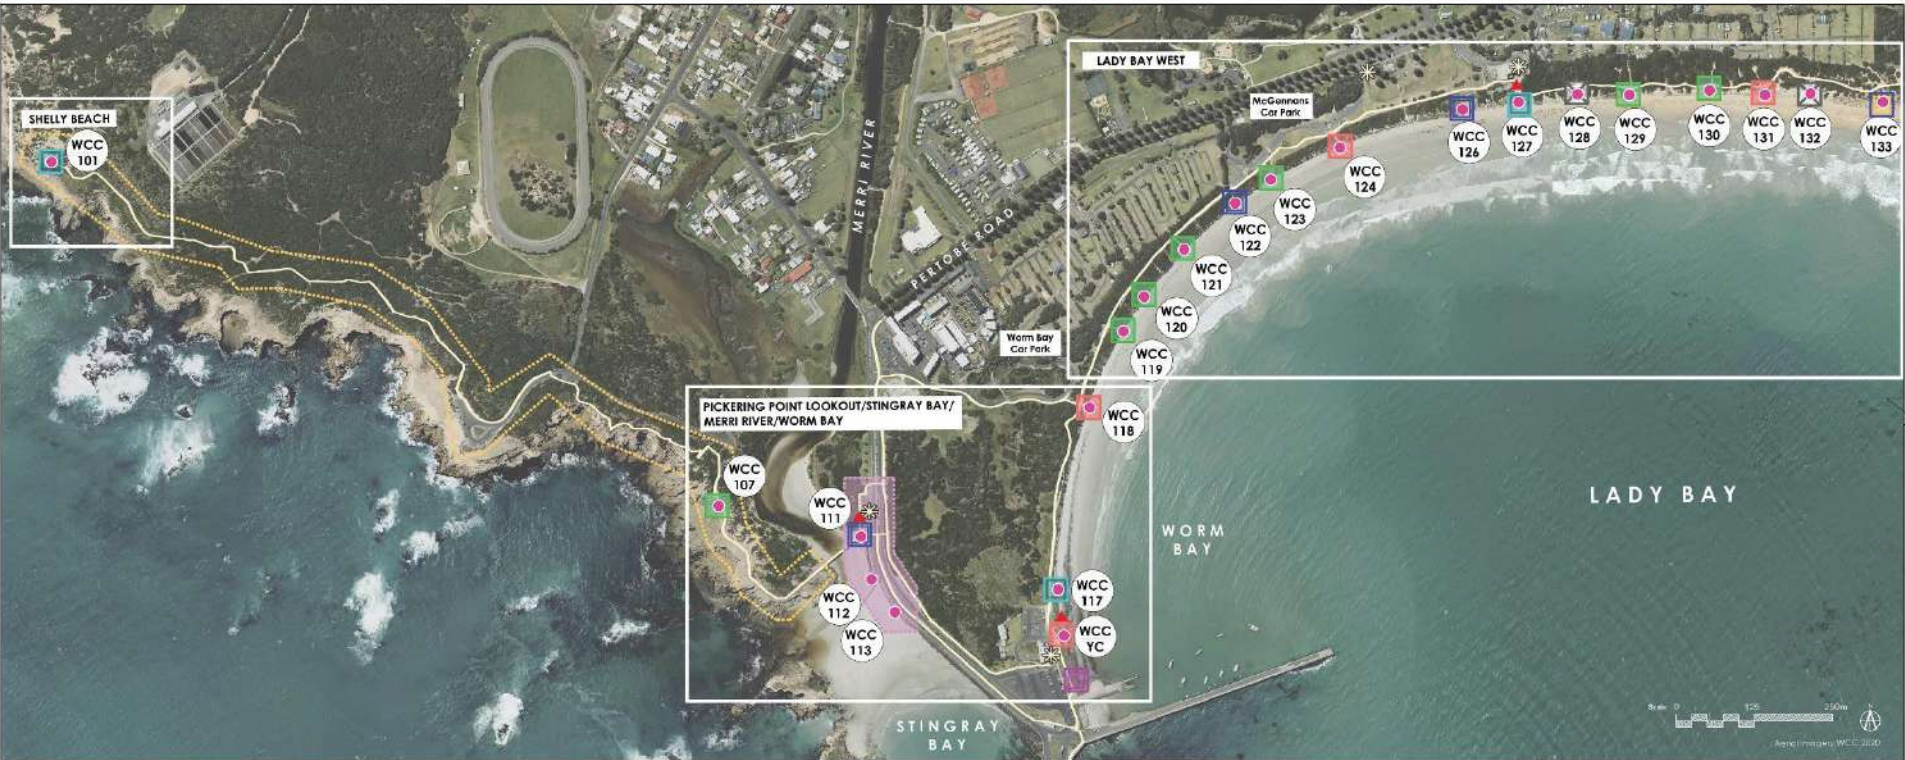
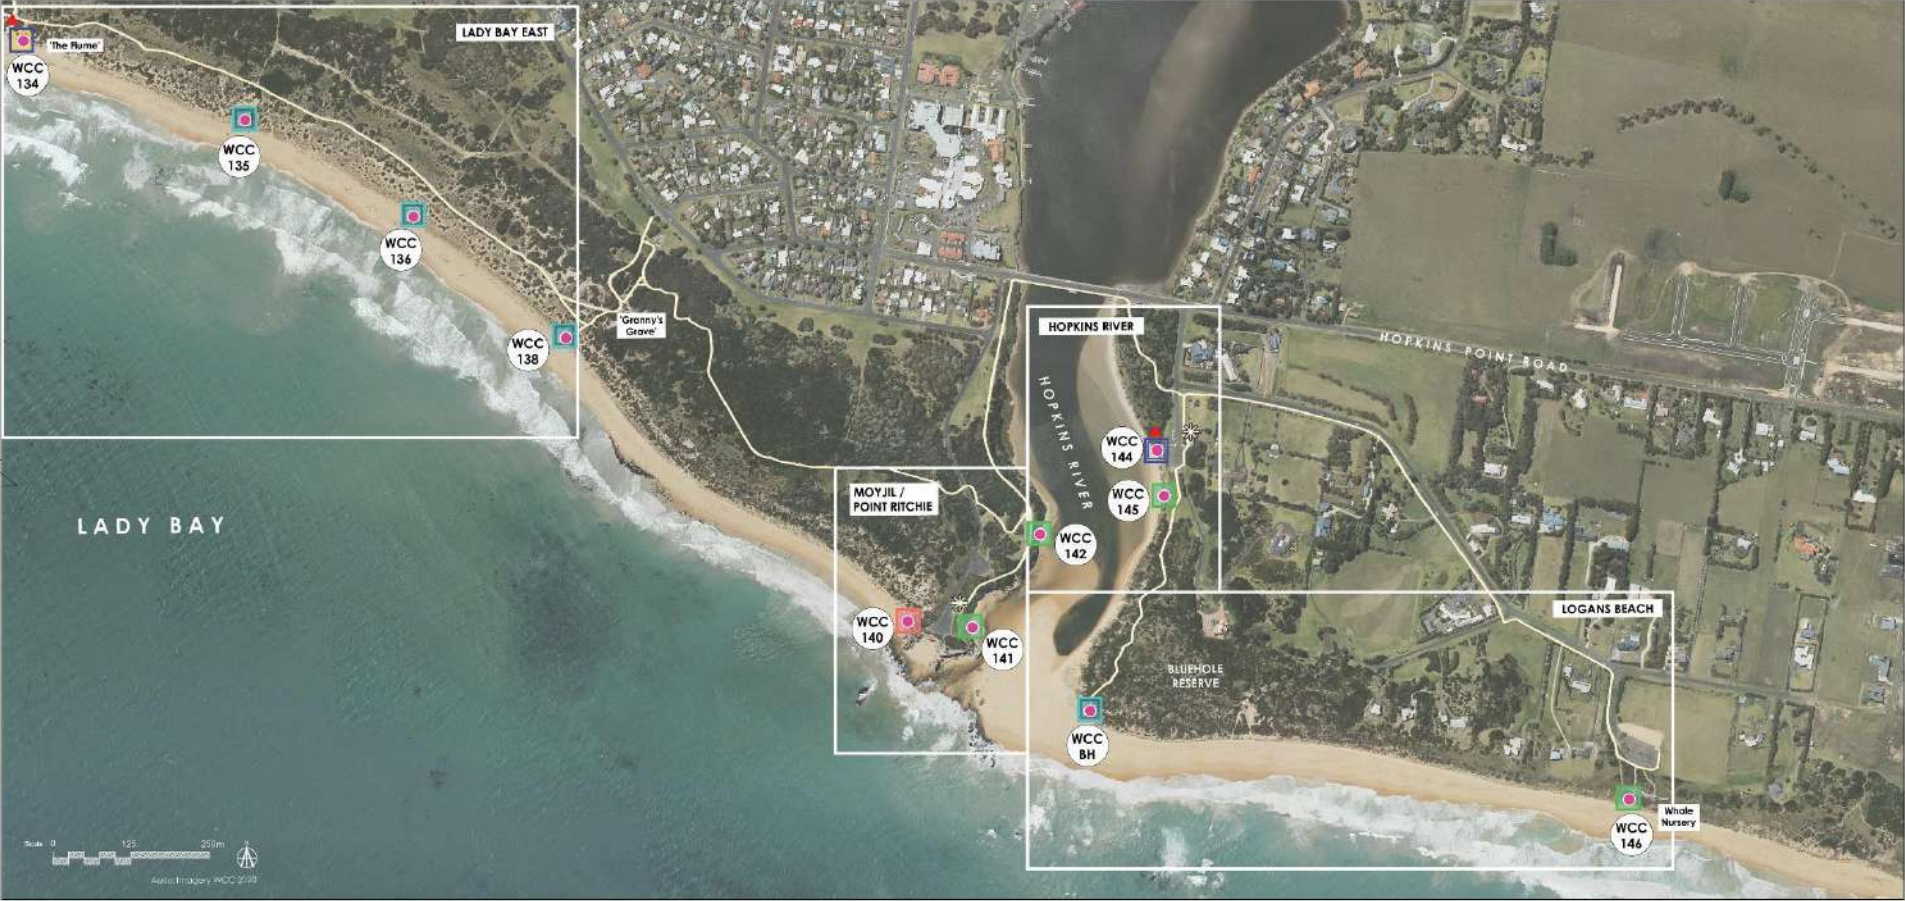
WARRNAMBOOL BEACH ACCESS - RECOMMENDATIONS PLAN (WEST)

- LEGEND
- Beach Access Point (33 in total within study area)
 - Retain**
Recently constructed staircase structure:
Worm Bay WCC118
McGennans WCC124
Lady Bay WCC131
Moyjil/Point Ritchie WCC140
Recently upgraded boat ramp:
Worm Bay WCCYC

- Retain and improve**
 - Replace with accessible ramp**
Incorporate handrails, landings, tactile ground surface indicators
 - Replace with staircase**
Incorporate handrails, landings, tactile ground surface indicators and contrasting strips on stairs

- New accessible ramp**
Incorporate handrails, landings, tactile ground surface indicators
Currently no constructed beach access at this location
 - Consolidate with accessible ramp**
Consolidate WCC133 and WCC134 providing a single location for beach access. Replace with ramp (incorporating handrails, landings, tactile ground surface indicators). Provide all-terrain vehicle (ATV) access in consultation with emergency services.

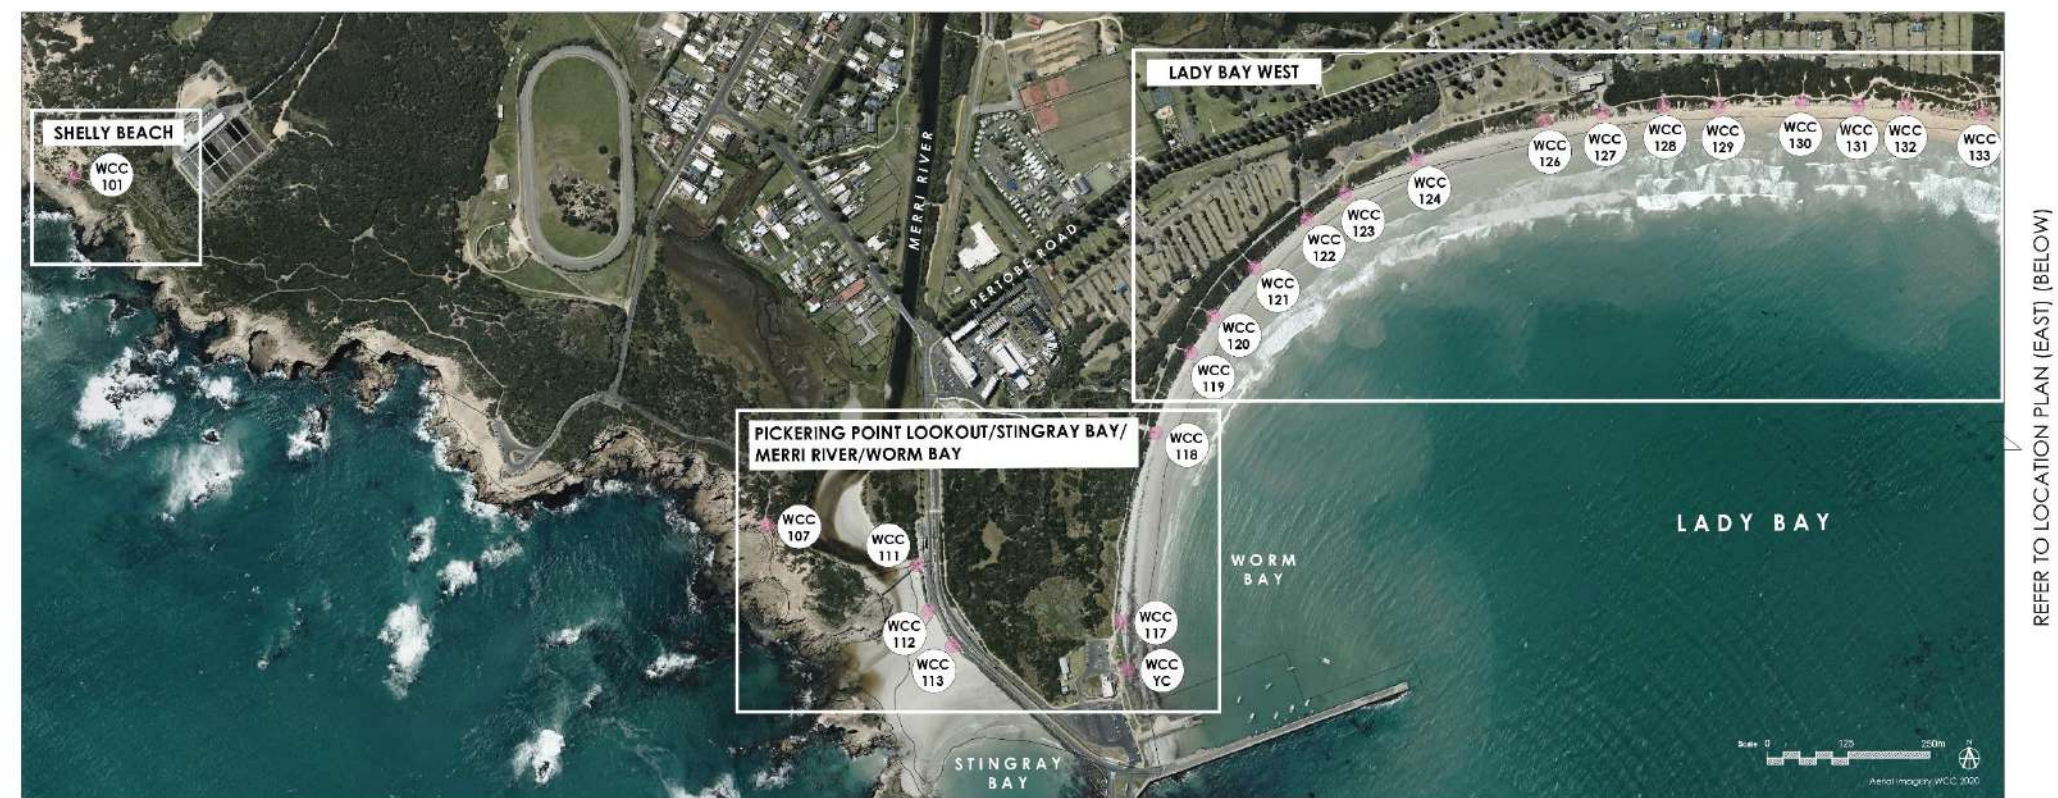
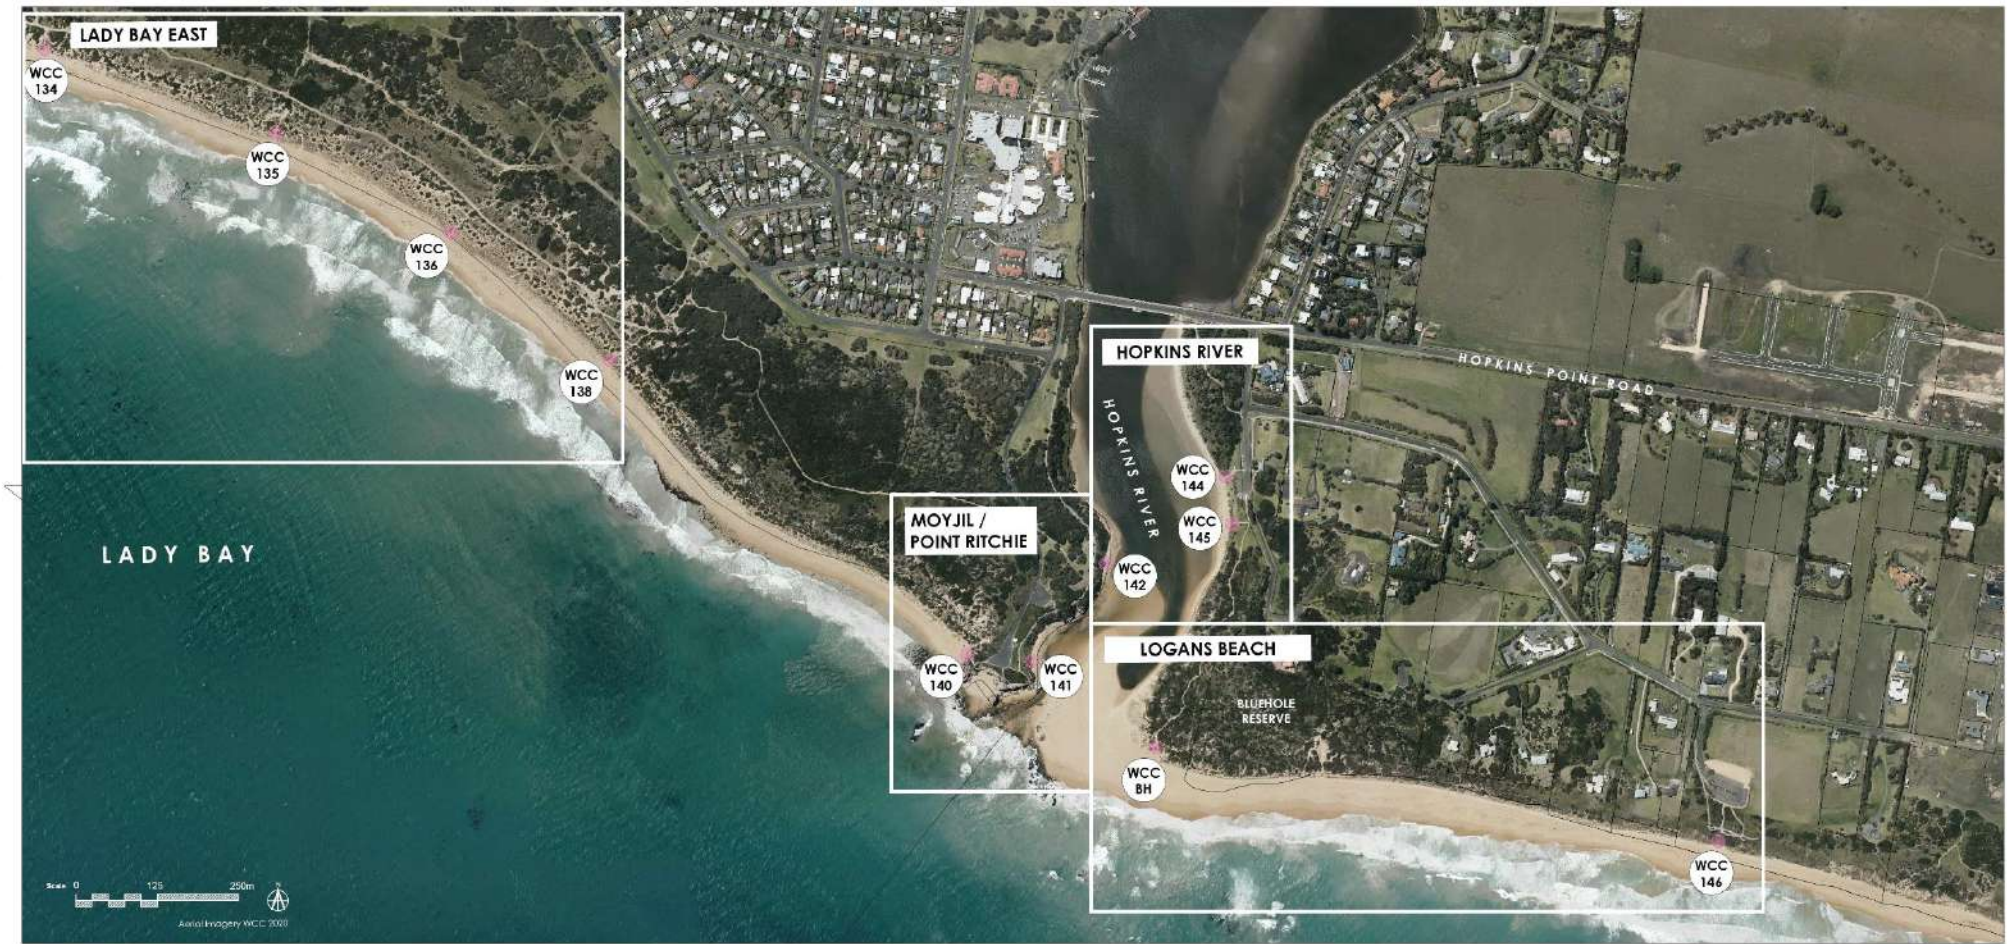
Figure 2: Beach Access Point Location Plan (with reference ID)

These 33 beach access points are included in this Beach Access Strategy for Warrnambool. The study area and 33 existing beach access points are shown at Figures 1 and 2.

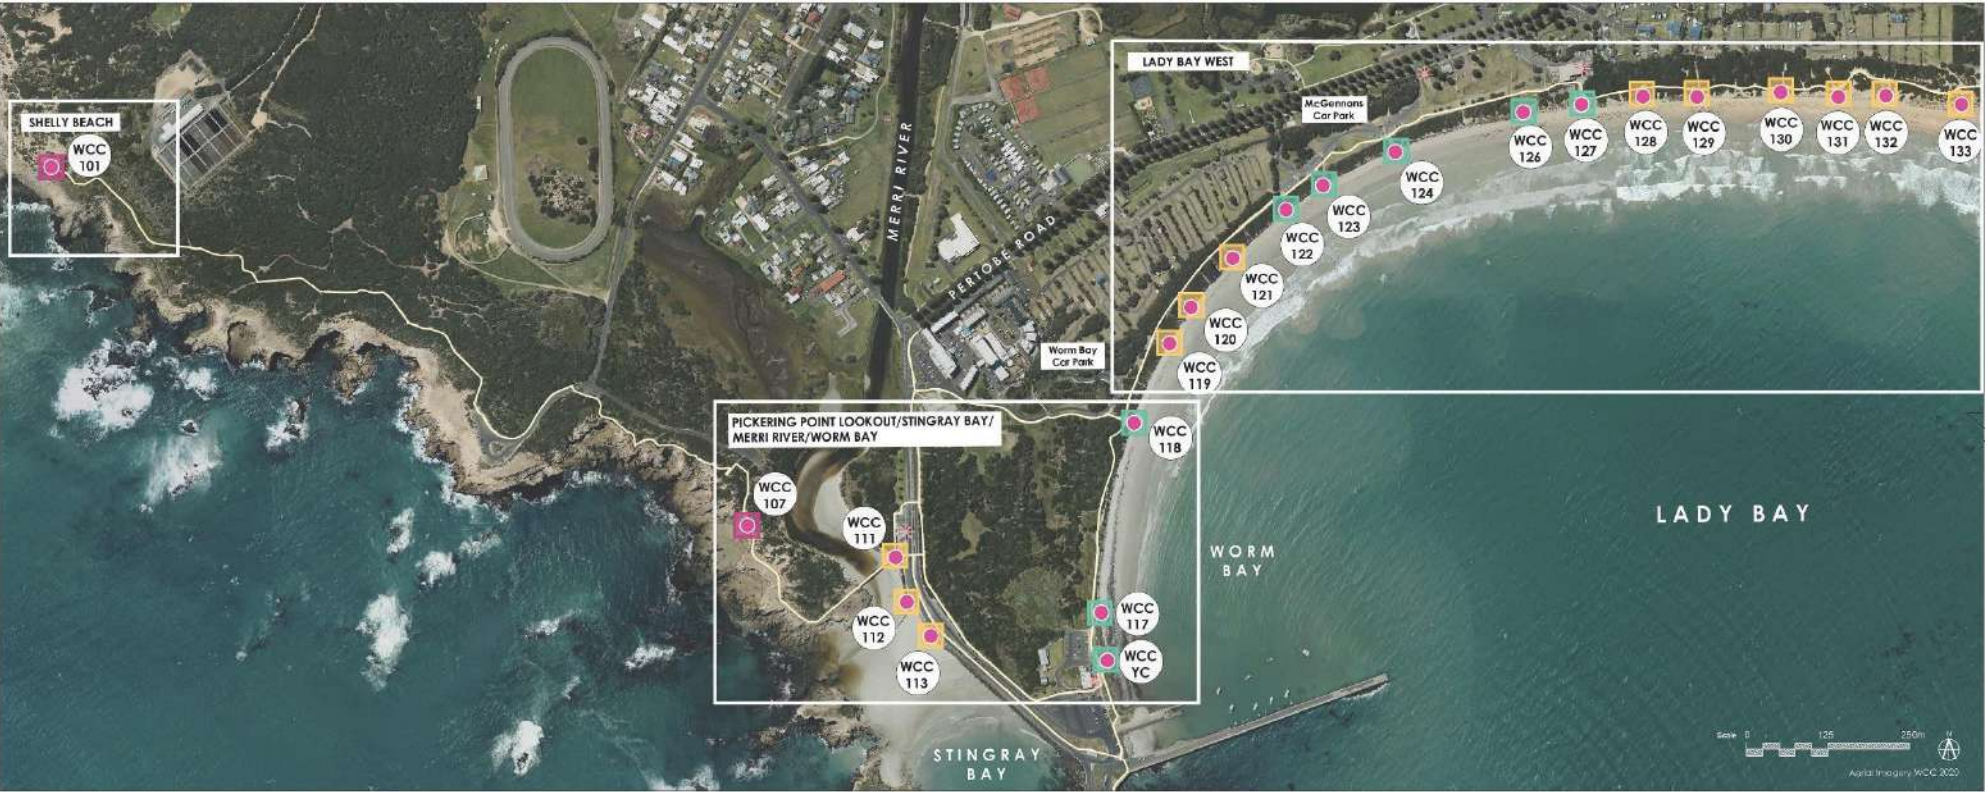
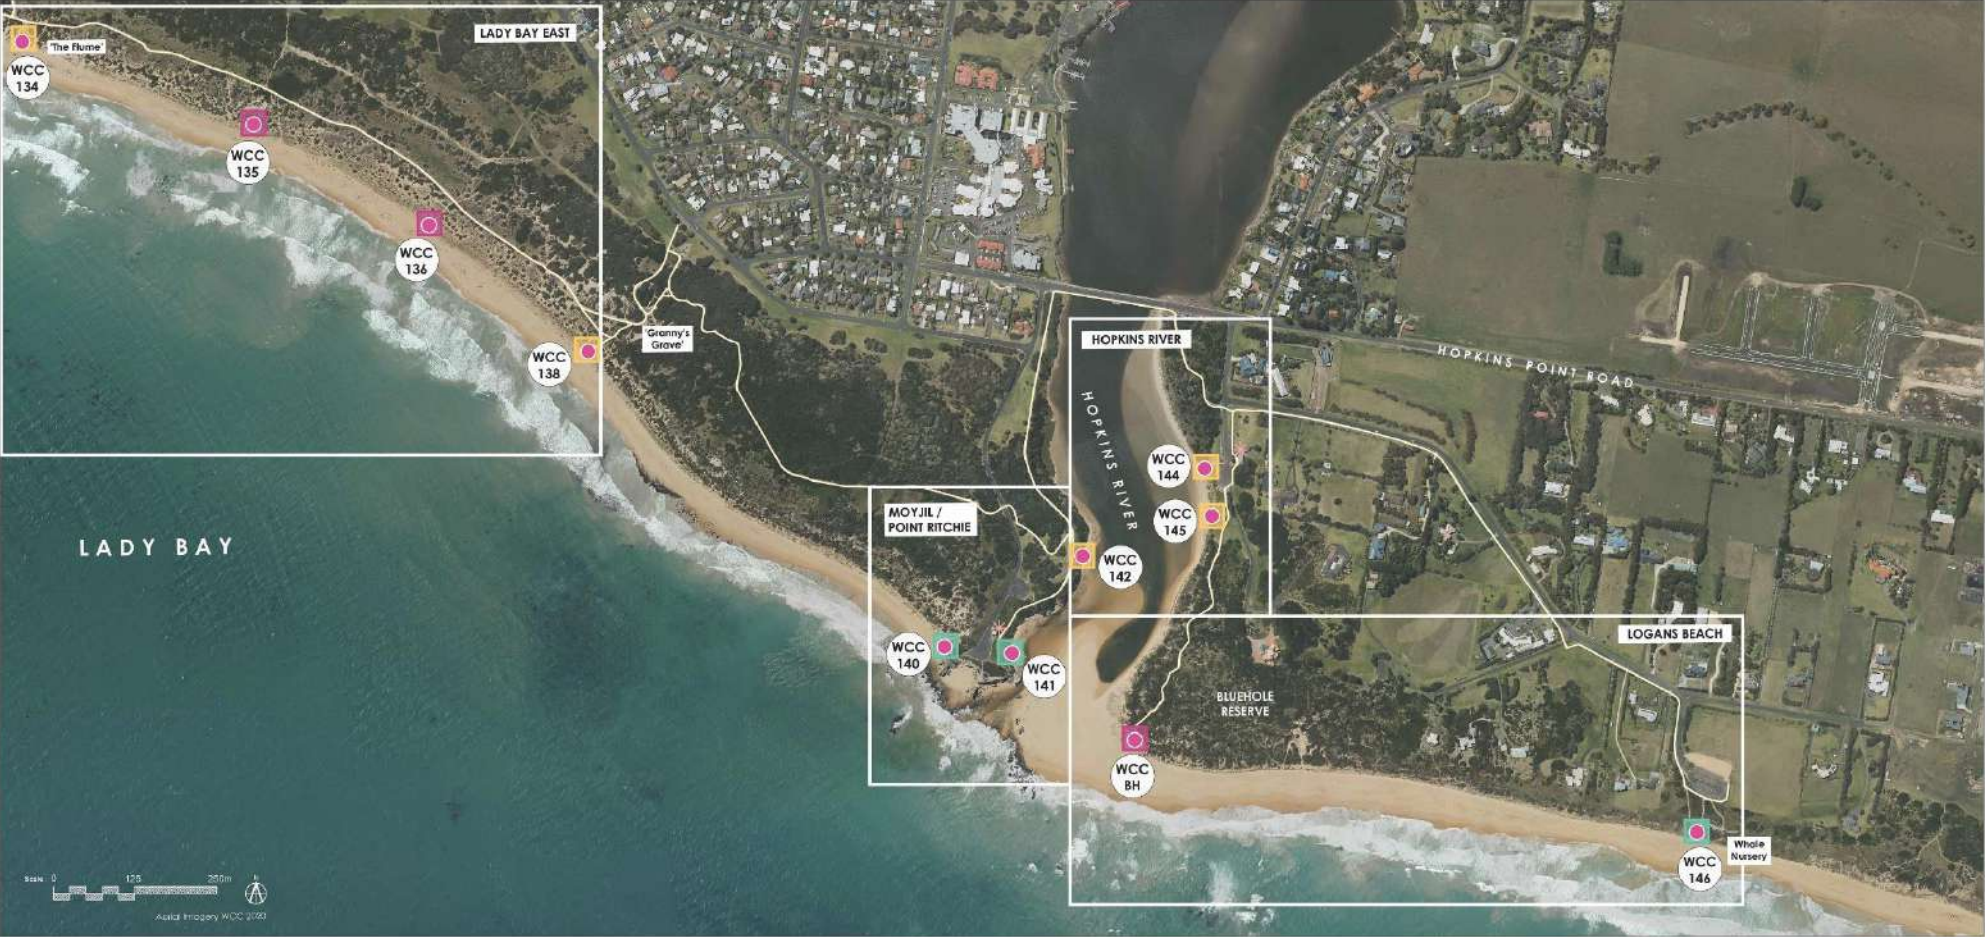
Figure 11: Beach Access Peak Usage Plan

There are a variety of different service levels, which generally align with the usage level. Refer to the Usage Plan at Figure 11. Usage and service levels have been divided into three categories:

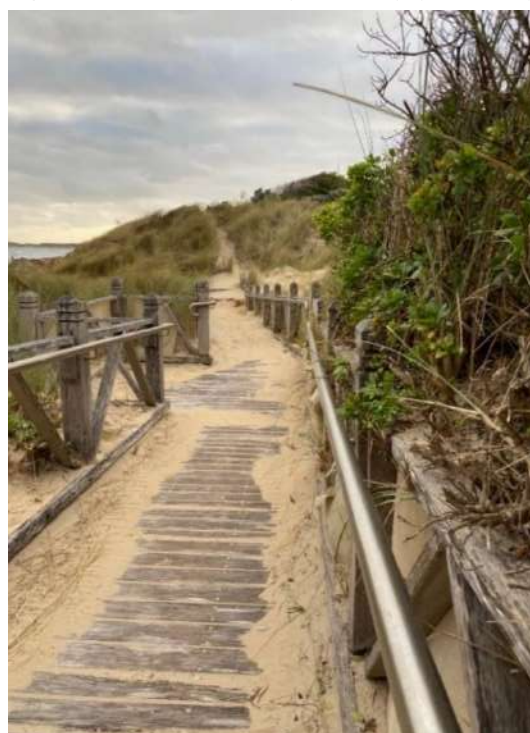
- Grades/steepness of some staircases and timber boards and chains.
- Sand coverage and build up over structures (Figure 12)
- Erosion of sand and steep drop-offs at base of some stairs/access structures
- Surveillance and sightlines. Particularly along the beach foreshore trail where taller vegetation exists blocking views and creating safety concerns for users, particularly at intersections between the shared trail and path access points. (Figure 13)
- Horses
- Isolated nature of places, such as Shelly Beach (WCC101) and Pickering Point (WCC107)
- Cliffs, steep embankments, steep dune embankments.
- Inadequacy of fencing in some locations
- Materials and maintenance (splinters, warped stair treads)
- Anti-social behaviour, including lighting of fires

Figures 12: Sand build up on ramp (WCC126)

11. The existing accessible ramp near the Warrnambool Surf Lifesaving Club WCC126 is subject to regular access maintenance issues due to its design, construction materials and proneness to sand build up. It is recommended that this access ramp be replaced with a new accessible ramp. The design and siting of the accessible ramp near the Warrnambool Surf Lifesaving Club WCC126 should be undertaken at the same time as the plans for the proposed surf lifesaving club upgrade/extension to ensure good planning and access to and from main building entrance/s and car parking areas. It is also recommended that a second accessible ramp be provided in Lady Bay West near the eastern end of the holiday park due to it being a high usage area with good path access from the McGennans car park. WCC122 may be an appropriate location for an accessible ramp subject to further investigation of the dune morphology and detailed design.

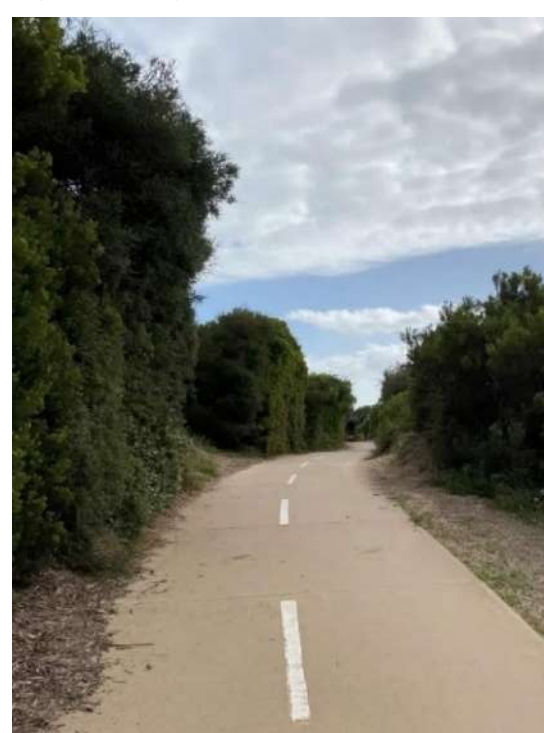
Perceptions of safety have a strong influence on people's walking preferences and vegetation overgrowth was cited by a number of survey respondents in relation to safety. If people feel as though they are putting themselves at risk in certain locations they are more likely to avoid those environments.

Figure 13: Vegetation close to trail

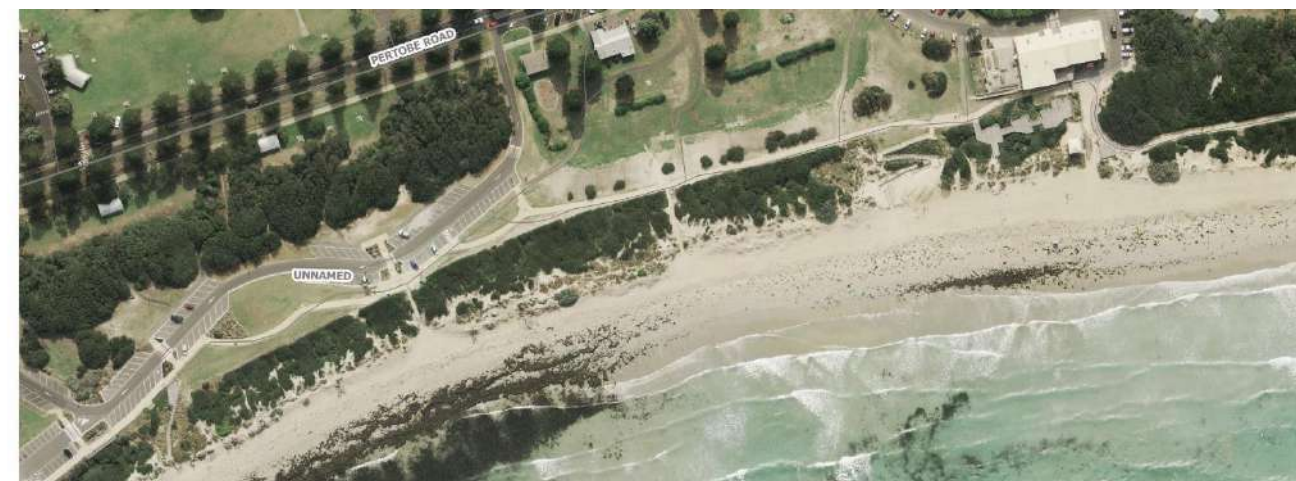
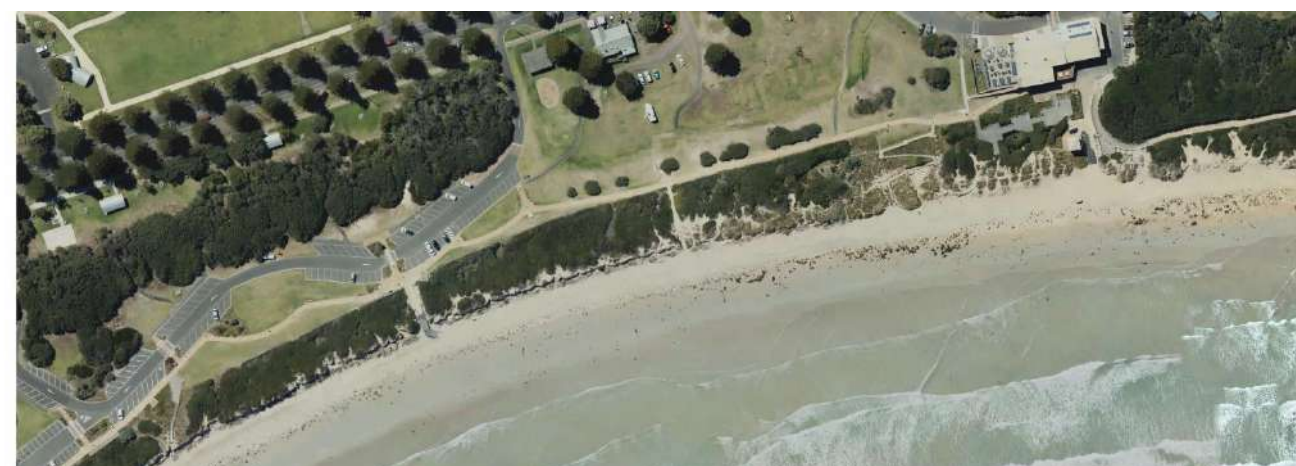
Figures 18 and 19 – Show vegetation and dune changes to the west of the Surf Lifesaving Club between 2015 (top) and 2020 (below). Erosion has increased along the dune face which has changed the dune morphology and there is an increase in density and coverage of Coast Tea-tree (Aerial image sources, Geovic, 2015 and WCC, 2020)

Whilst the Coast Tea-tree provides erosion control by stabilisation of the sand by the root systems, it was noted on site visits that underneath the Coast Tea-tree the sand movement tends to occur in channels and this may be due to the lack of tufted graminoids and groundcovers present. In areas where the Coast Tea-tree has died and the area has been revegetated, the maintenance staff have found that leaving the root system of the dead tree in place helps erosion control while the newly planted vegetation establishes.

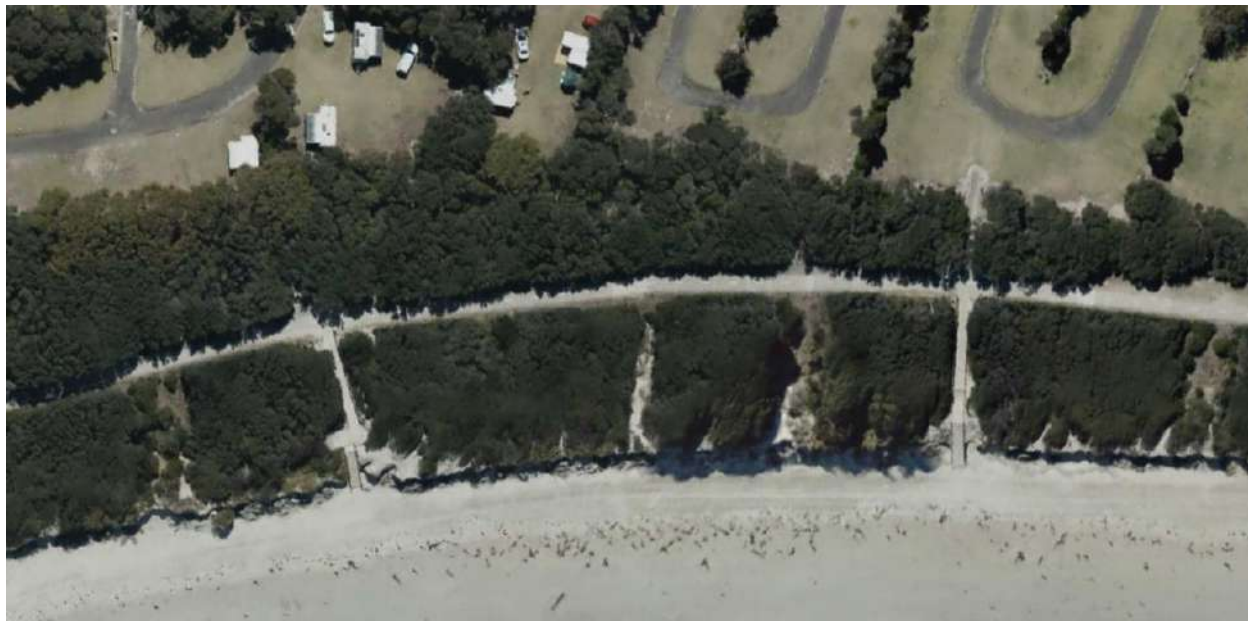
Figure 20: Thick Tea-tree adjacent existing paths and access points (Aerial image source, WCC, 2020)

The Coast Management Plan 2012 recommended that management of the Coast Tea-tree should involve *'careful lopping and trimming of up to one third of the height or volume of native trees ensuring the health of the tree is not compromised'* (Biosis, 2012, p. 16) The Management Plan did not recommend removal of Coast Tea-tree. However, this recommendation from 2012 requires a review, as it may be appropriate for some areas of Coast Tea-tree to be removed and replaced with indigenous species that are lower growing and do not significantly inhibit sightlines, particularly near path intersections and key beach access points.

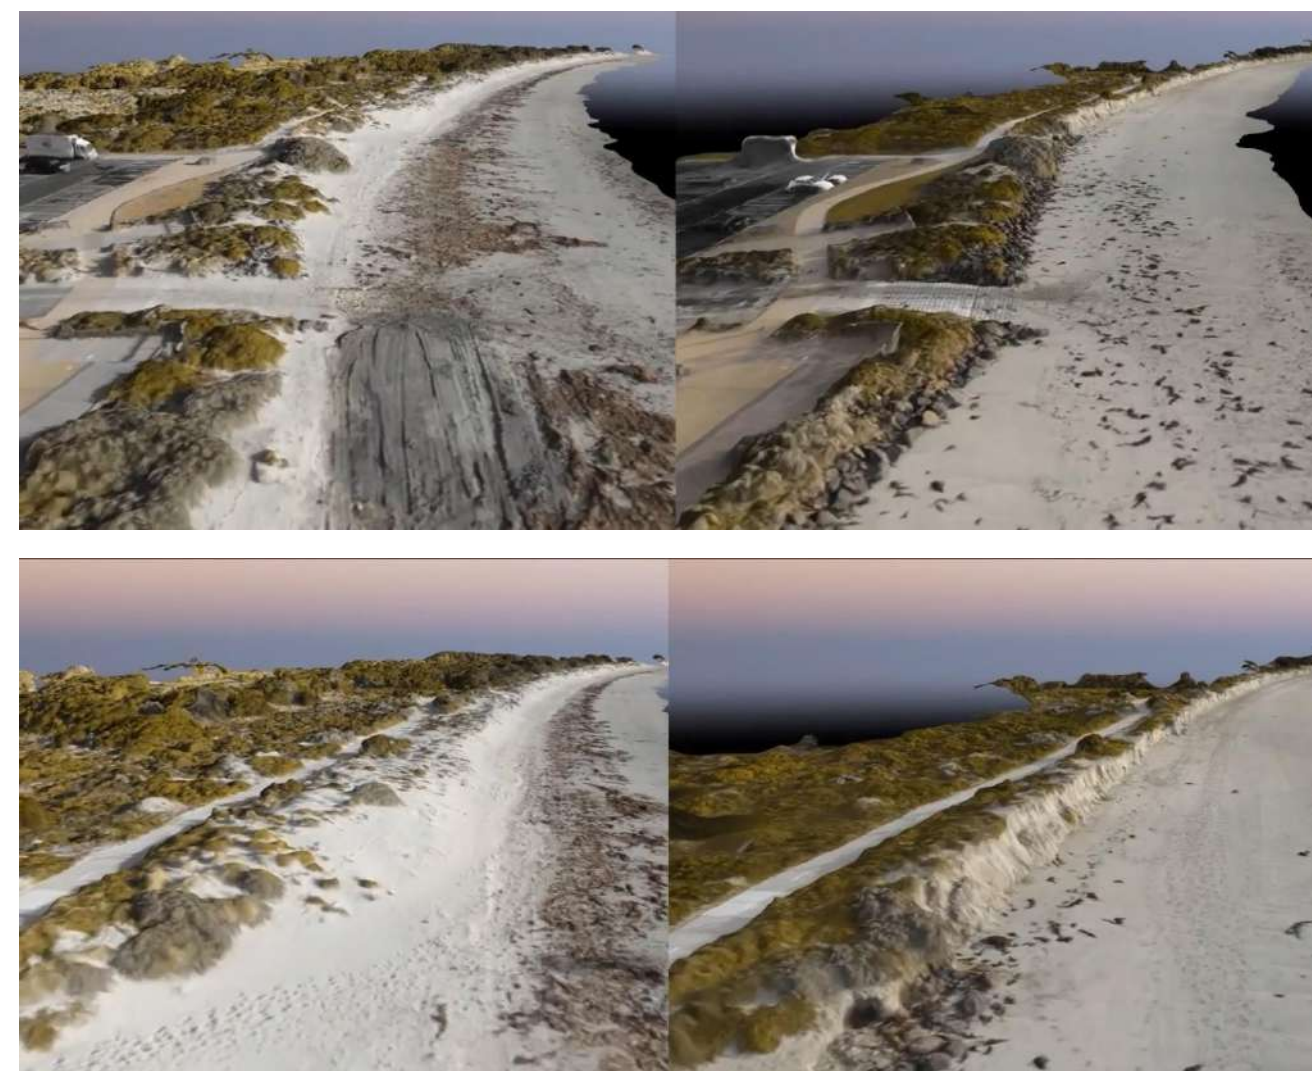
Figures 21 and 22: Pre- (top) and Post- (below) 2014 storm event drone imagery (Deakin, 2022)

Images Sourced from the Victorian Coastal Monitoring Program (Deakin, 2022)

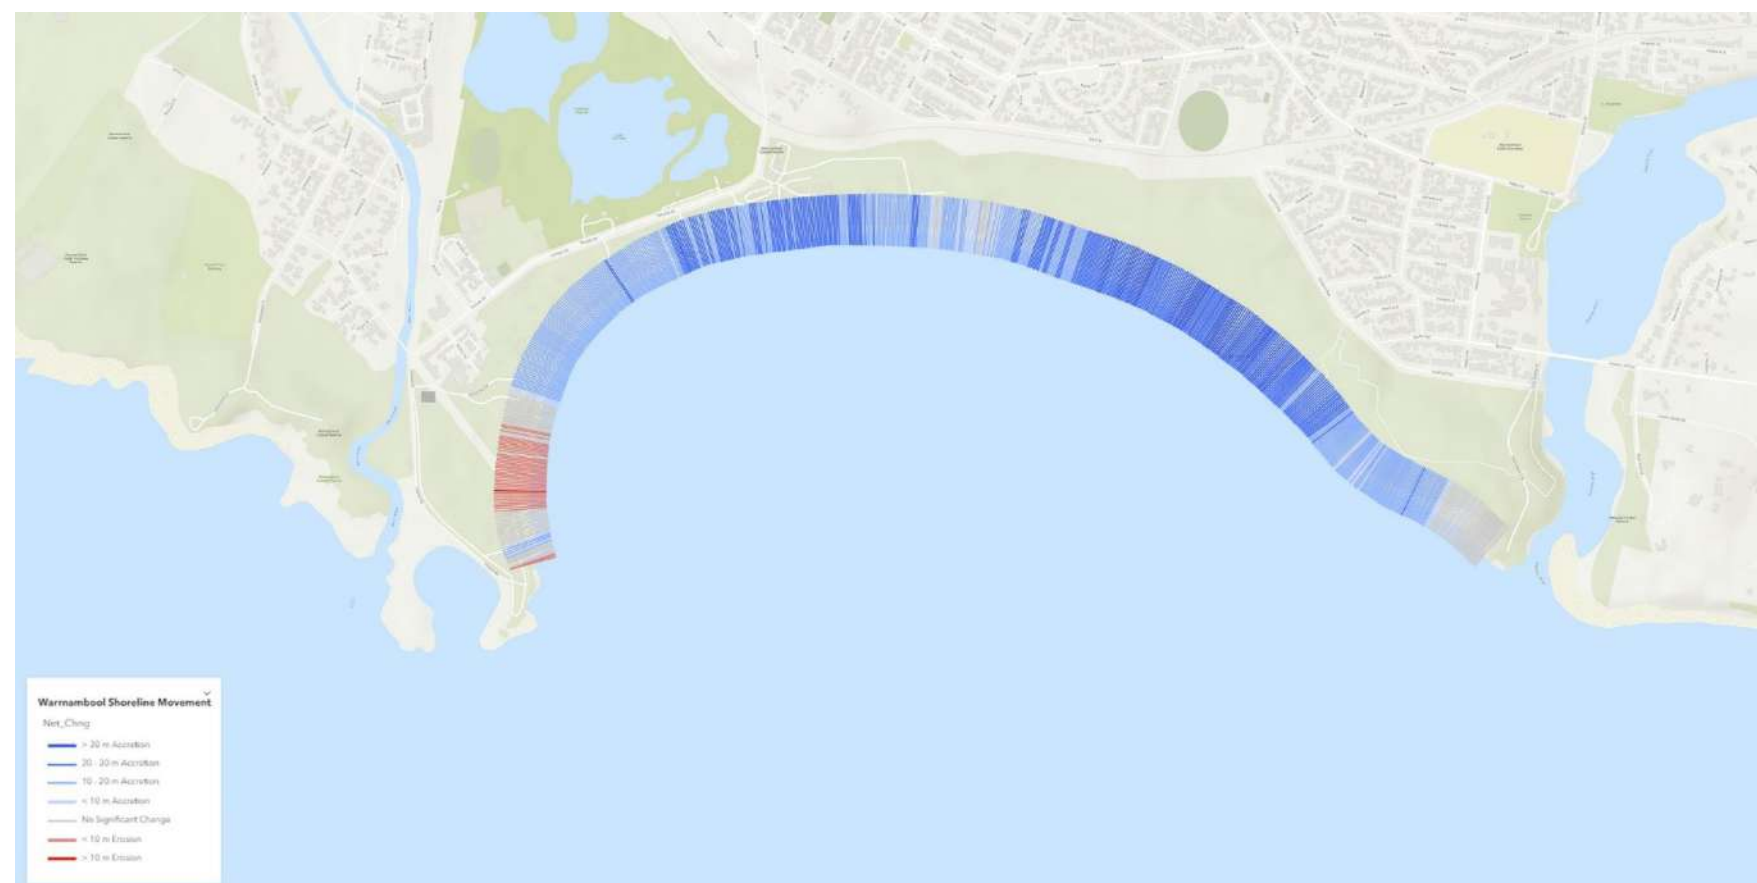
Figure 24: Net Shoreline Movement 1969 to 2019 (vegetation line mapping) (Deakin, 2022)

'The majority of the Warrnambool beach (83.3%) has experienced some amount of accretion over the past 50 years from 1969 to 2019, while erosion accounts for 6.0% of the change in shoreline position. No significant change was found at the remaining 10.7% of transect locations. Most of the erosion is occurring in the western end of the beach area next to the breakwater. Accretion is occurring across the rest of the beach with a few areas of no significant change interspersed. You can explore specific areas of interest by navigating around the map' (Deakin, 2022)*

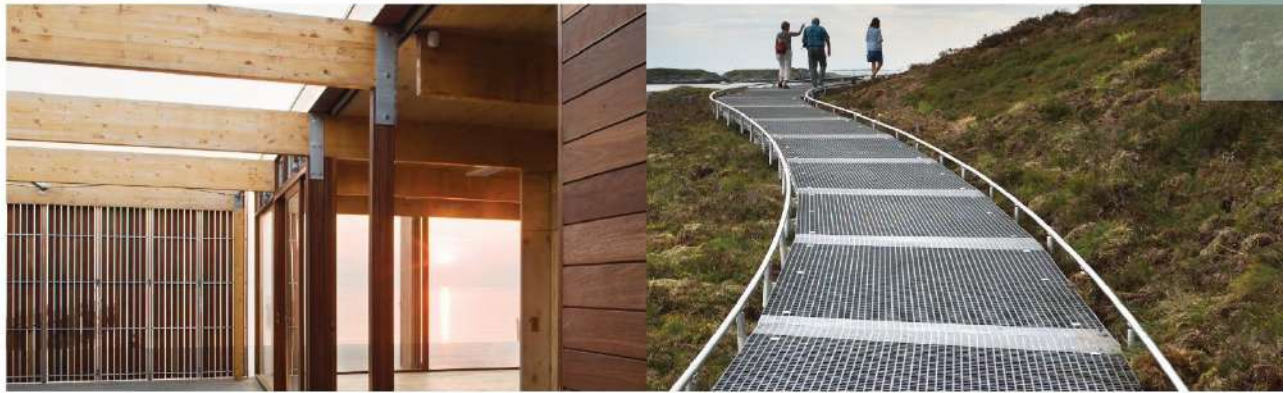
STANDARD MATERIALS PALETTE

Hardwood timber - plantation - grown and recycled timber treated for protection from insects and decay - Red Gum, Jarrah and Tallowood are most durable and suitable for structure is the water.
Photo: John Gollings

Reinforced polymer mesh - lightweight - chosen for its excellent anti-corrosive and low maintenance properties.
Photo: Roger Ellingsen

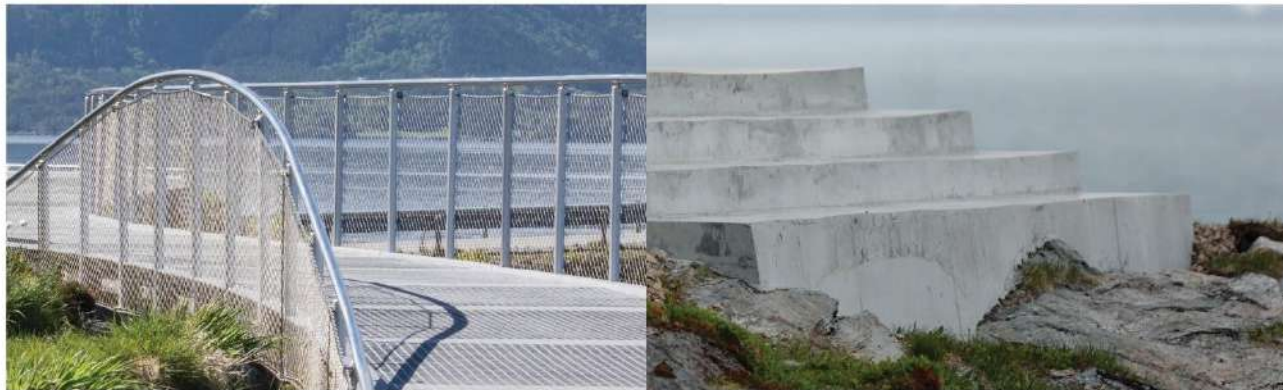
Steel - structural grade and hot dip galvanised as per AS/NZ 4680 for superior performance and powder coated for corrosive protection.
Photo: Jarle Waehler

Concrete - durable providing there is adequate cover to all reinforcement to prevent corrosion. Photo: Jarle Waehler

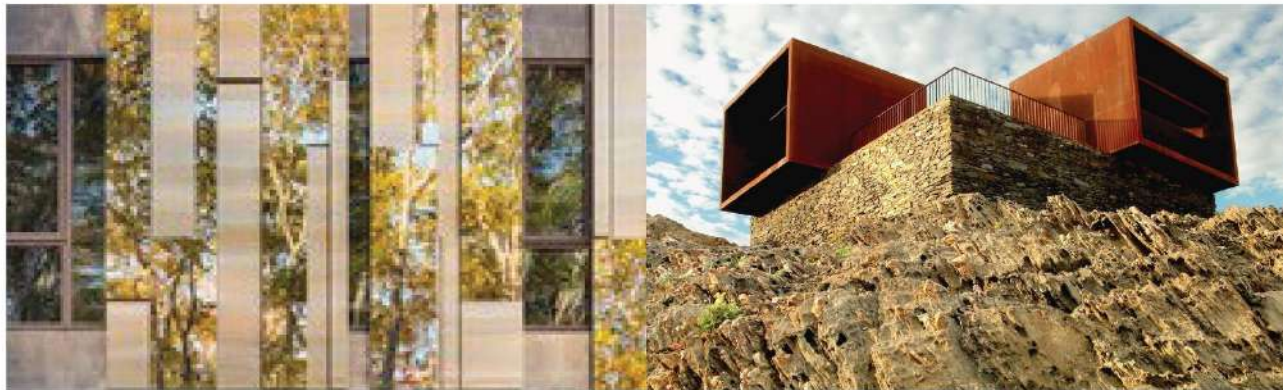
Glass - needs special consideration to avoid glare and reflection. Photo: Peter Aaron

Natural stonework - very durable and requires no special treatment. Photo: EMF Architects

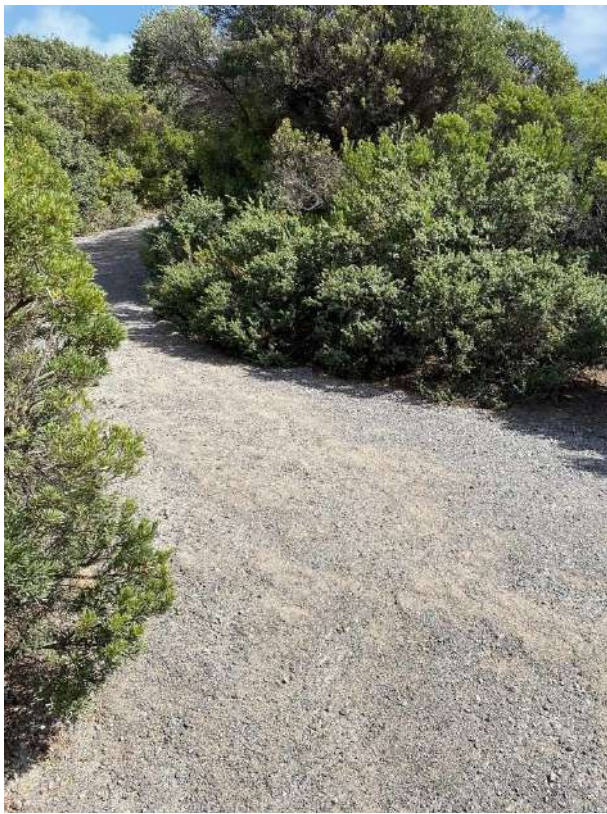
The track to Shelly Beach from the Thunder Point Lookout car park is approximately 900m long and constructed mostly of gravel. The path passes south of the water treatment facility.

Figure 27 – WCC101 track to Shelly Beach

2. Investigate opportunities to make safety improvements to Shelly Beach WCC101. Changes may include fencing and surface improvements.
3. Carry out fencing repairs and additional fencing between the Merri Bridge and Shelly Beach to ensure walkers stay on the main track and avoid threats to significant cultural heritage places and deter people from going near cliff edges.

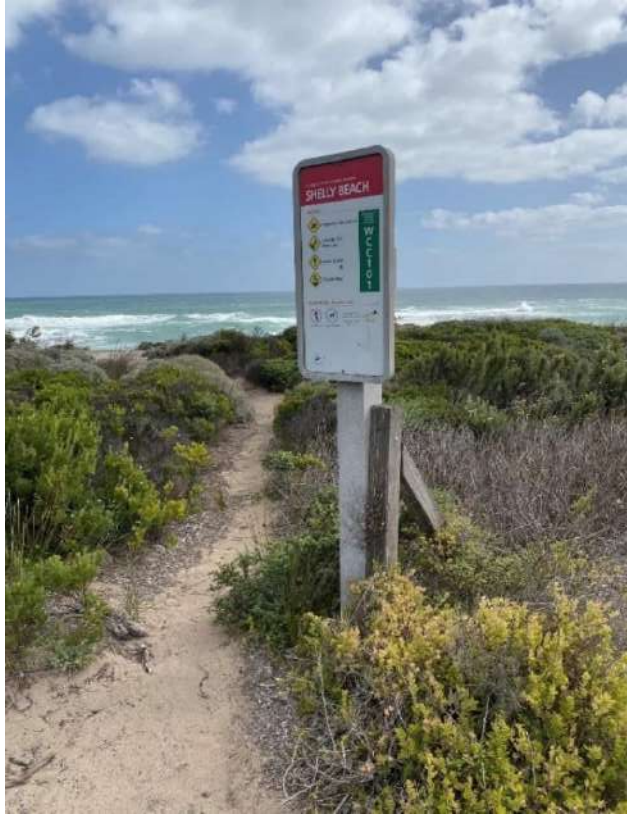
Figure 28 – WCC101 track to beach

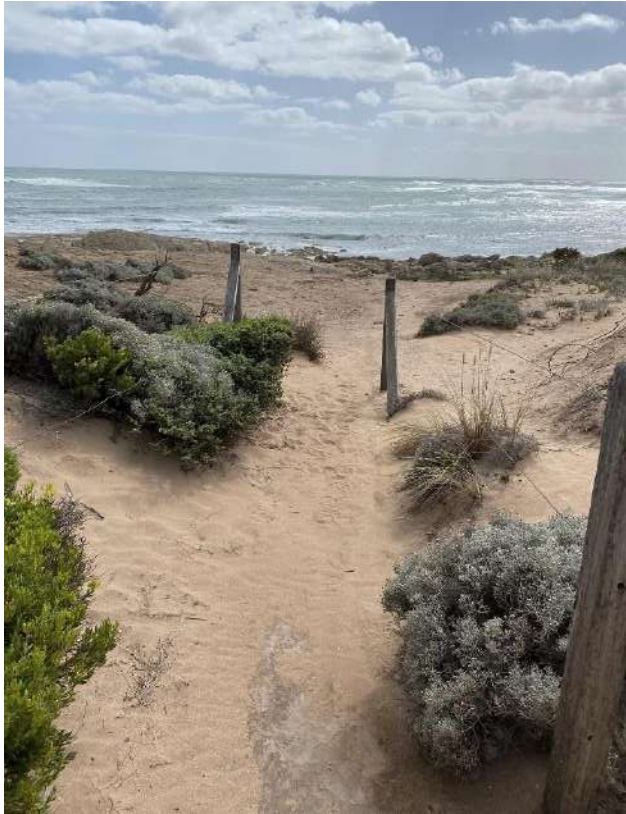
Figure 29 – Post and wire fence

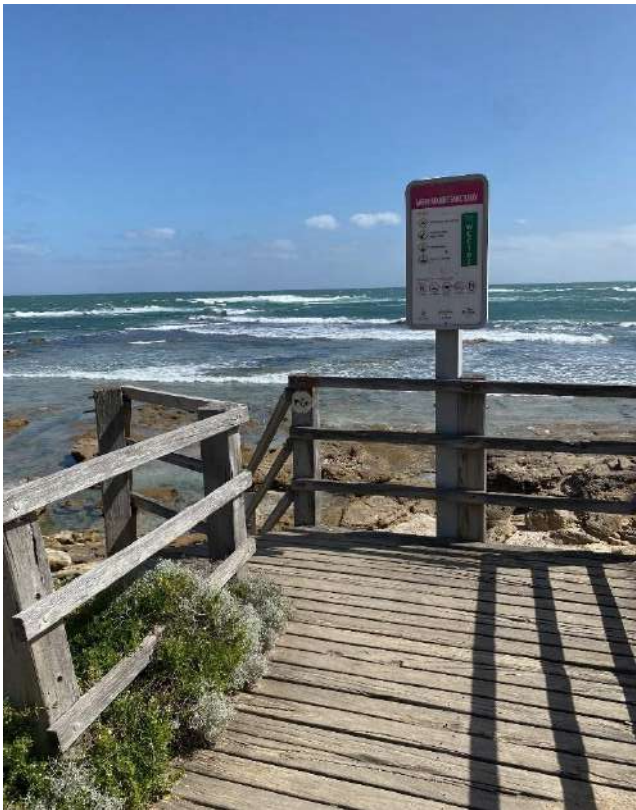
Figure 33 – WCC107 Top landing

4. Install signage to direct visitors along the main tracks to Shelly Beach.
5. Replace existing staircase at beach access WCC107 near Pickering Point. The suitability of this location as a beach access point should be investigated as part of the safety audit.

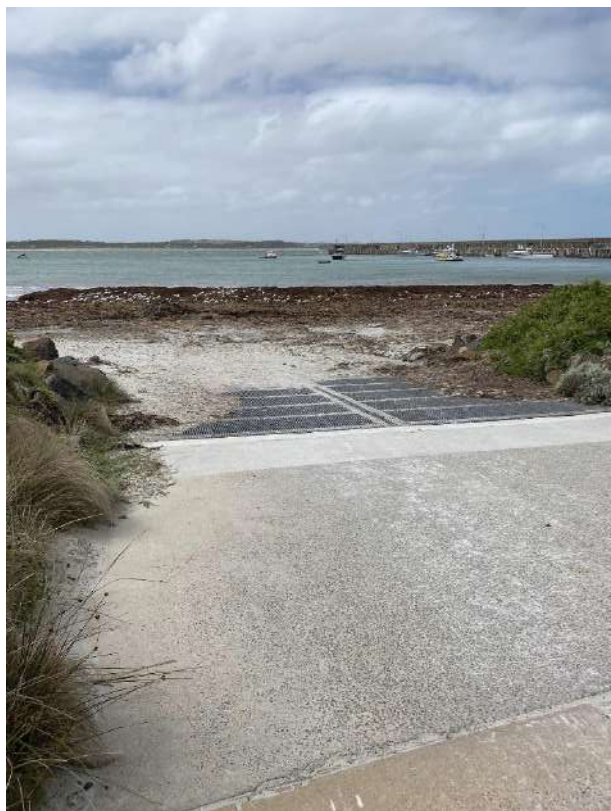
In Worm Bay, the Warrnambool Yacht Club have access to the launching ramp which does not have a WCC number. This is referred to as WCCYC for the purposes of this Strategy. The horse racing industry utilizes WCC117, which is an access ramp constructed for horse training access to the beach. Whilst these two access points have not been constructed for the purposes of pedestrian access, pedestrians still utilise them to gain beach access. The next nearest pedestrian access point is located at WCC118, which is also close to the Worm Bay car park. This access structure has recently been upgraded with a new staircase constructed to replace the previous timber one.

Figure 41 – WCCYC (Boat launching ramp)

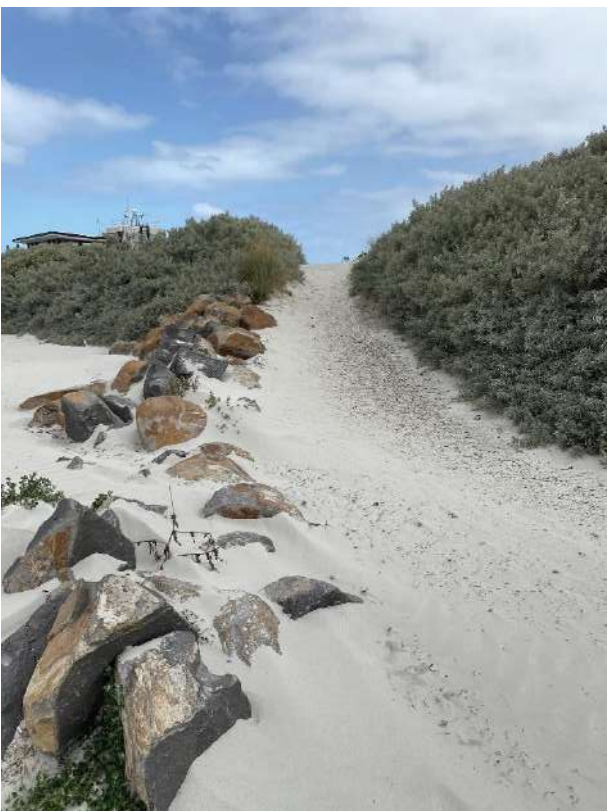
Figure 42 - WCC117 (Horse training access)
