Warrnambool Beach Access Strategy

The recommendations of the Strategy are intended to provide guidance for Warrnambool's 33 beach access points between Shelly Beach and Logans Beach, over a 15-year timeframe.

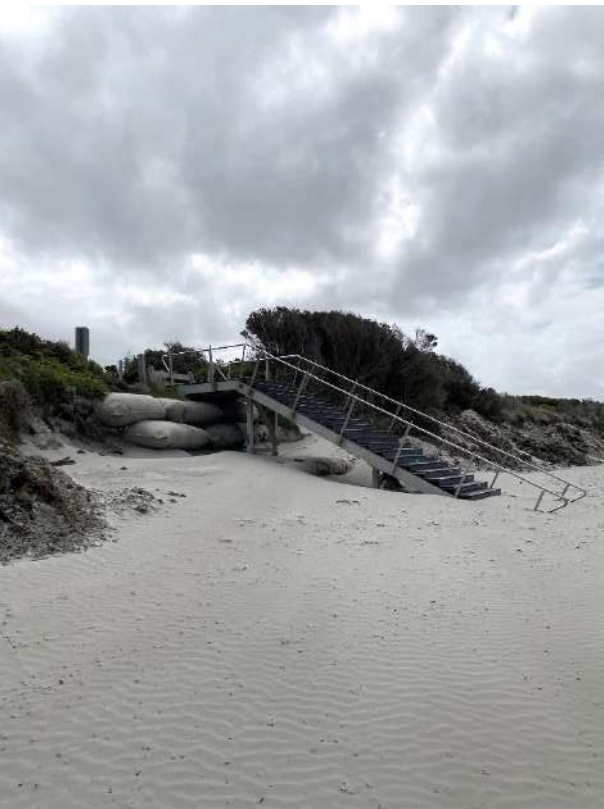
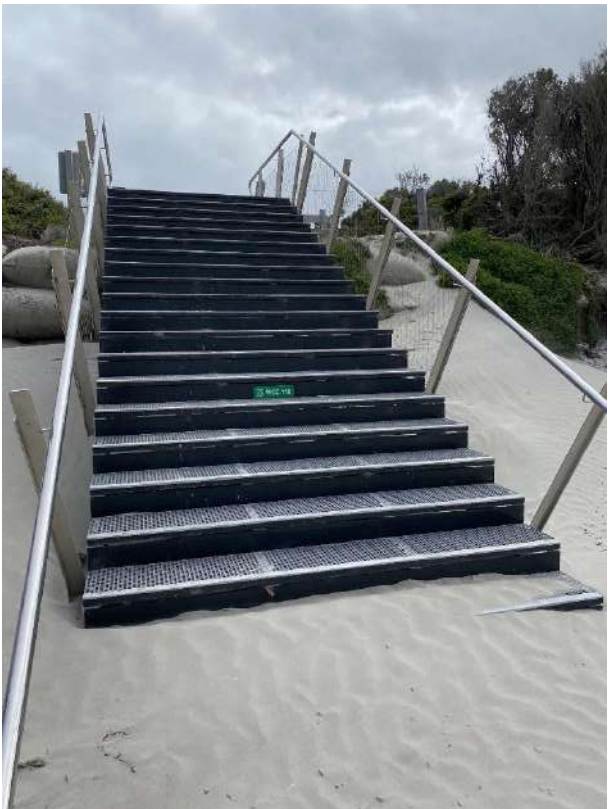
Figure 44 – WCC118

In Worm Bay, the Warrnambool Yacht Club have access to the launching ramp which does not have a WCC number. This is referred to as WCCYC for the purposes of this Strategy. The horse racing industry utilizes WCC117, which is an access ramp constructed for horse training access to the beach. Whilst these two access points have not been constructed for the purposes of pedestrian access, pedestrians still utilise them to gain beach access. The next nearest pedestrian access point is located at WCC118, which is also close to the Worm Bay car park. This access structure has recently been upgraded with a new staircase constructed to replace the previous timber one.

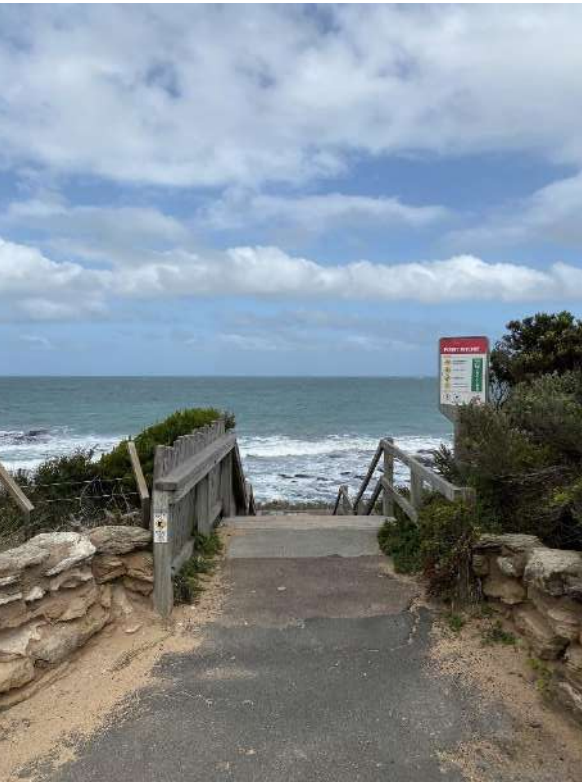
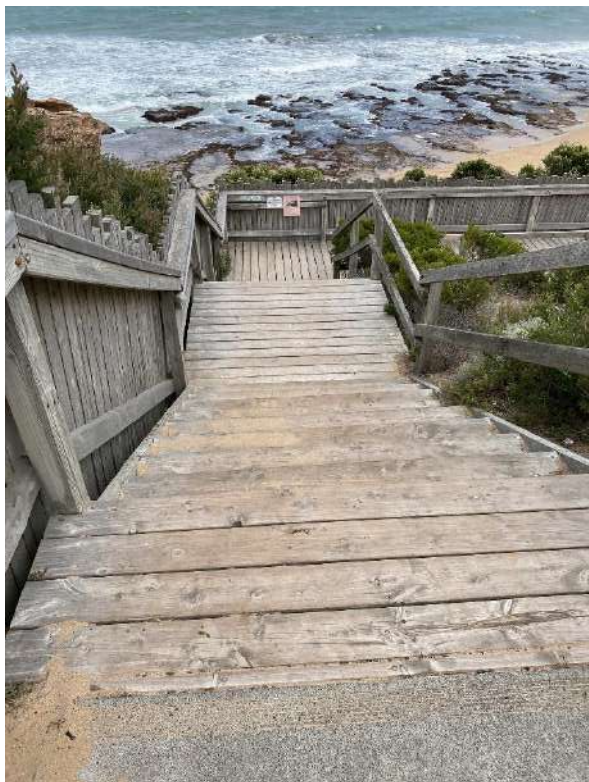
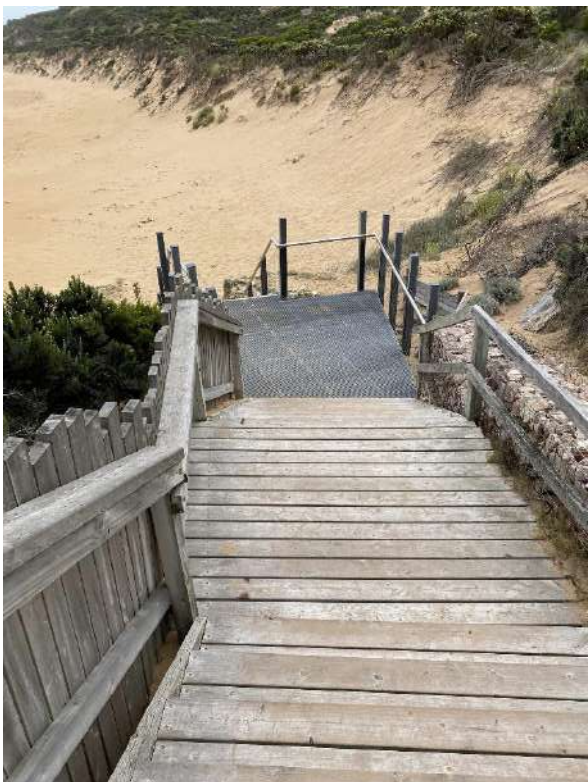
Figure 69 – WCC140

Access structure WCC140 has recently been upgraded with a new staircase constructed to replace the previous timber one. Access WCC141, which provides access to the Hopkins River estuary is nearing the end of its useful life.

17. Retain access points at Point Ritchie / Moyjil WCC140. This is a relatively new structure with a long remaining useful lifespan.
18. Replace staircases at Point Ritchie/Moyjil WCC1141 and Hopkins River WCC142 and WCC145.
19. Construct accessible ramp at Hopkins River WCC144 to accommodate wheelchairs and people with special access requirements. Provide all-terrain vehicle access to beach in this location for improved emergency access (although vehicle access is dependent on tidal levels)
20. Investigate opportunities to make safety improvements to Logans Beach access WCCBH. Changes may include fencing and surface improvements. New ESTA marker required at this location.
21. Replace staircase at Logans Beach WCC146. Replace timber stairs between the existing viewing platform/deck and beach. This is a current project in the planned capital works program.

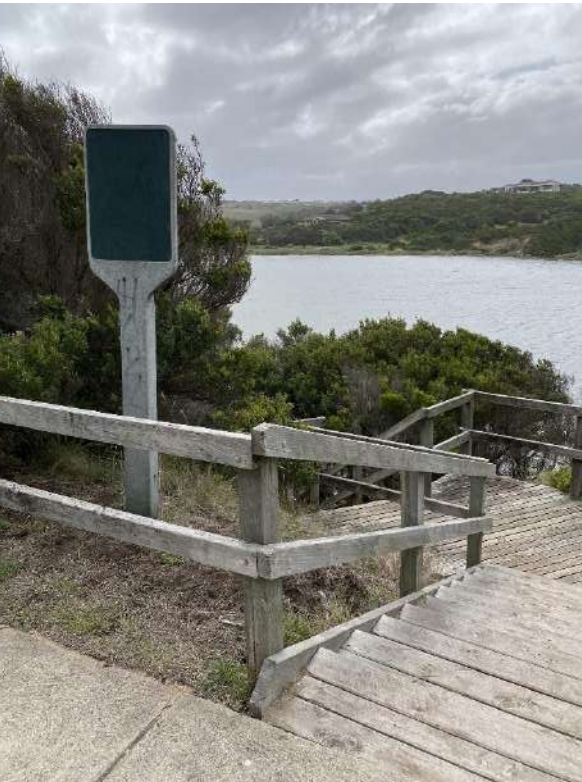
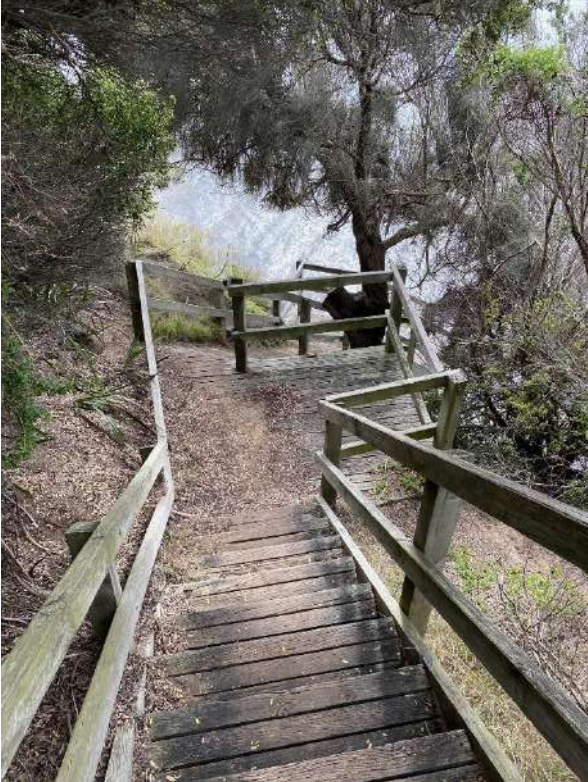
Figure 75 – WCC142

Access point WCC142 is a steep staircase that provides access to the west side of the Hopkins River estuary. Anecdotally it is utilised for recreational fishing.
